## Coastal Engineering Solutions for Remote Pacific Island Communities

*Stuart H. Bettington – AECOM Australia Pty Ltd*

This paper explores innovative and affordable coastal protection strategies tailored for remote Pacific atolls, particularly in Tuvalu, which face increasing threats from sea-level rise and extreme weather events. Authored by Stuart H. Bettington (AECOM Australia), William Blank (Hall Pacific), and Robyn C. Bussey (AECOM New Zealand), it focuses on the use of large sand-filled geobags as a practical alternative to conventional coastal defence structures like rubble or concrete seawalls. The authors draw from firsthand project experience in Tuvalu following Tropical Cyclone Pam in 2015, which caused widespread erosion and flooding. Two major interventions are highlighted:

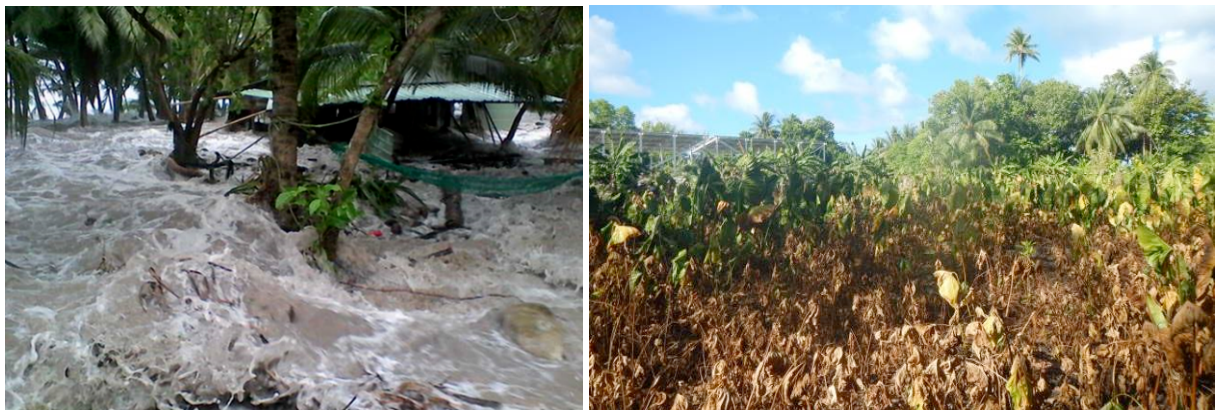
Figure 2 Marine flooding, caused by TC Pam on Nanumea, Tuvalu, and Gardens destroyed by

contaminated ground water on Nukulealea, Tuvalu (Source Public Works Department GoT).

In March 2015 Tropical Cyclone Pam, a large Category 5 system, passed through the western edge of the South Pacific sending large swell across the region and causing extensive damage. TC Pam did not impact Tuvalu directly; rather large waves from the cyclone travelled thousand kilometres to impact the west facing reefs of Tuvalu. Wave setup on the reef flooded islands and allowed large waves to reach the shore. As seen in Figure 2 this resulted flooding and structural damage was wide spread. Longer term contamination of the water table is a greater threat. Sea level rise is increasing the penetration of seawater into the island water tables. The impact of saline ground water on gardens is presented in Figure 2 where gardens have died after TC Pam flooding. If saline water impacts gardens regularly the future of the island communities is questionable. The relationship between ground levels and tide levels on the main island of Funafuti is seen in Figure 3, revealing the vulnerability.

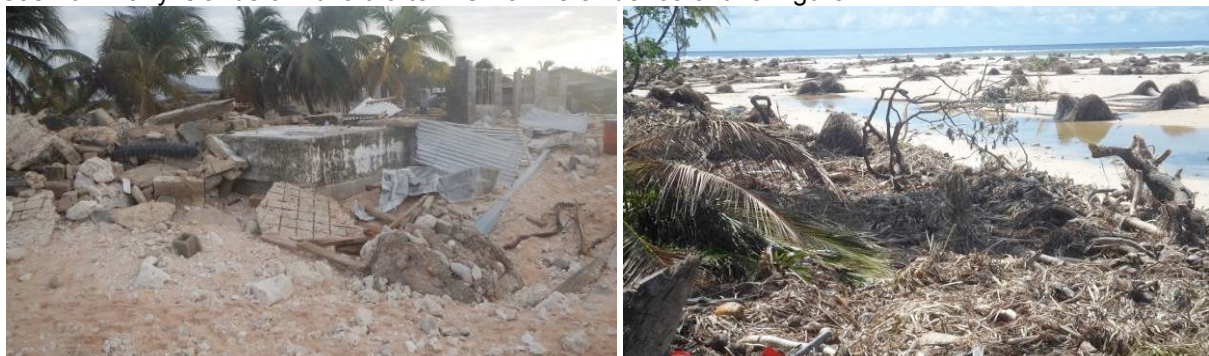
Figure 4 Erosion and damage caused by waves from TC Pam on Nui; and Sand and palm trees scattered across reef to edge following TC Pam on Nanumanga Tuvalu (Source PWD GoT).

The distribution of sand on the reef top represents a balance of the forces, mostly currents and waves. With changes in forcing caused by sea level rise, changes in intensity and frequency of cyclones or the impact of works such as dredged channels the distribution of sand is altered. The dramatic erosion seen on many islands of Tuvalu after TC Pam is evidence of this Figure 4.

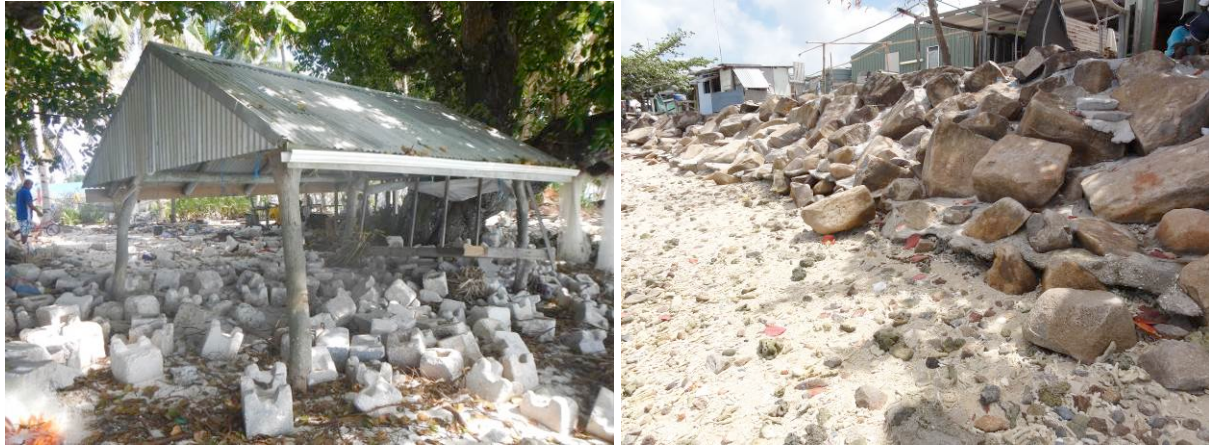
Figure 5 Sand and modified cube armour blocks deposited through community of Nukulaelae after TC Pam, Tuvalu (Source PWD GoT); failed seawall on a sand starved beach on Iama, Torres Strait.

Sand that is washed off the reef platform is lost to the system, and requires healthy coral and lengthy periods of mild conditions to be replaced. Further each time a major cyclonic system washes over the islands sand is lost to coastal processes as it is deposited on the island, raising it slightly, as demonstrated with the deposits. Coastal erosion has the dual impacts of reducing the land available on these small islands, and reducing the amenity of the islands, with the loss of sandy beaches as seen in Figure 5.

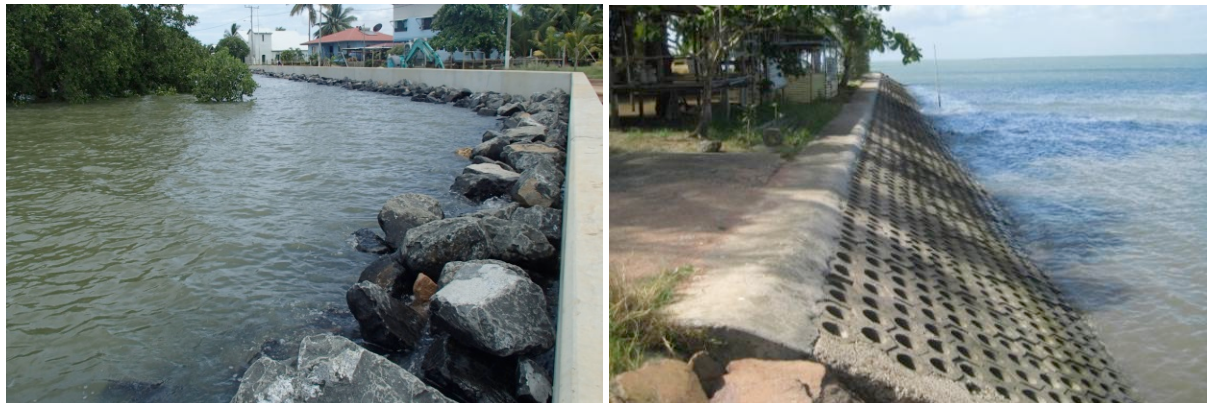
Figure 6 Hard seawalls with rock armour seawall with concrete barrier to exclude high water levels on Saibai, and a rigid seawall of small pattern placed Seabee armour units on Boigu, Torres Strait.

- Conventional hard engineered structures, including rubble seawalls (coral blocks, rock or concrete armour) and rigid seawalls (pattern placed concrete armour such as sea bees or stone pitching), as seen in Figure 6.
- Geo-bags – very large, robust sand bags (Figure 7).

The use of smaller armour units constructed into a rigid face represents a compromise that requires significantly less material, and can utilise local labour. A major issue with light armour solutions that rely on interlocking to achieve stability is the vulnerability to rapid failure mechanisms. This was evident on a number of islands in Tuvalu after TC Pam (Figure 5). An example of a more successful rigid or pattern placed seawall, with suitable edge details, is presented in Figure 6.

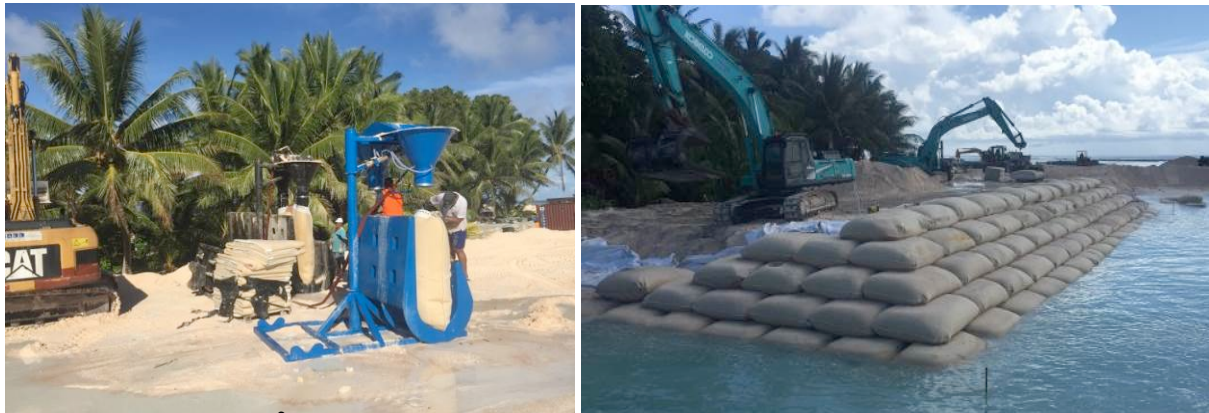
Figure 7 Filling 2.5 m<sup>3</sup> (~4 T) Geobags in a special frame and placing in a seawall - Nukufetau, Tuvalu. Note special attachment on excavator.

The bags are mounted in special frames to be filled with sand, as seen in Figure 7, before being sealed with stitching. The bags need to fill completely to achieve a good performance in the face. A significant advantage of this armour solution is that sand is typically a resource that can sustainably won on coral islands. Once filled excavators place the bags in a stretcher bond pattern, see Figure 7.

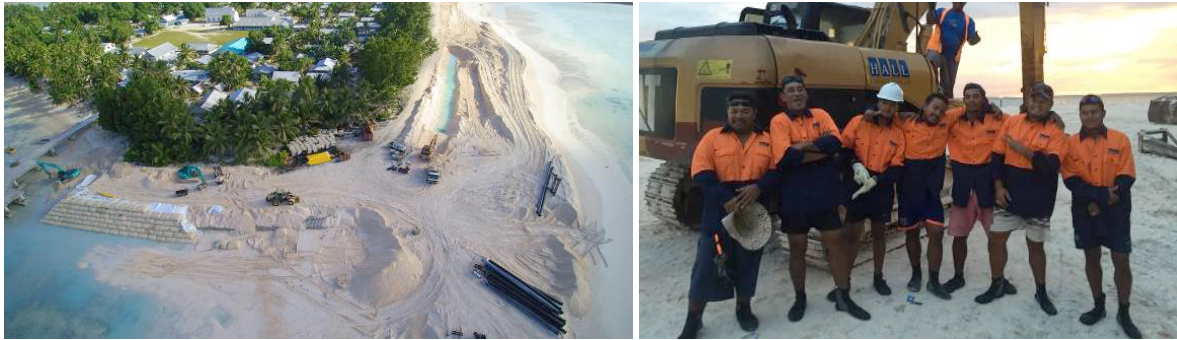
Figure 9 Works in progress and the local construction team on Nukufetau.

- Old damaged seawall buried.
- Construction new seawalls and groynes using 2,020 2.5 m<sup>3</sup> geobags.
- ~20,000 m<sup>3</sup> beach nourishment.
- Recycled coral armour used to repair seawalls.

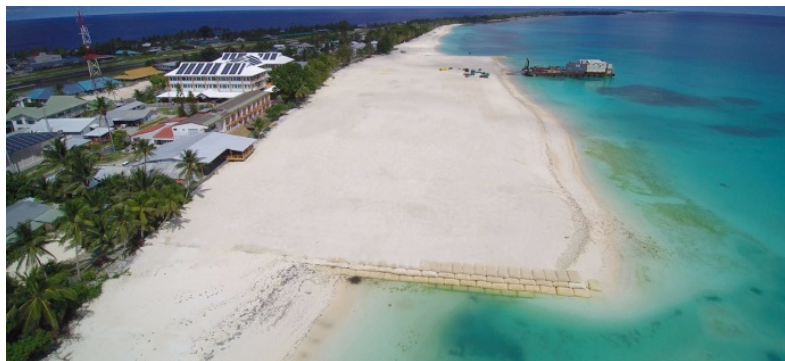
Figure 10 Completed Funafuti Recreation Area with groynes and nourished beaches, Tuvalu.

- Dredge 180,000 m<sup>3</sup> of sand, for reclamation and nourishing 1,500 m of foreshore.
- Construction of two 100 m long groynes utilising 608 2.5 m<sup>3</sup> geobags to contain reclamation.

The finished product as seen Figure 10 was delivered just 6 months after being initially discussed. The works improve the resilience of the community from lagoon side wave action and flooding and was well received by the 6,000 inhabitants in this land starved community. The project is significant for the islands coastal systems, and though currently not underway, monitoring of impacts would be prudent.

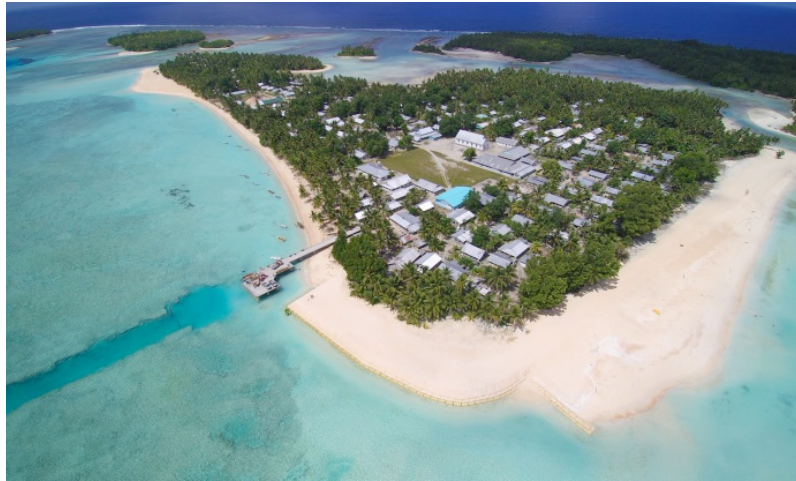
Figure 11 Finished works on Nukufetau, Tuvalu.

The finished product as seen in Figure 11 is attractive and was well received by the community. The seawalls address erosion concerns while the beaches improve the immunity of the community to flooding. Monitoring of impacts on the coast is not currently undertaken, though would be informative.
